# Manhole Inspection Summary

Manhole # S21EE\_020MH

**Location** Address: **1701 LAURENS ST**

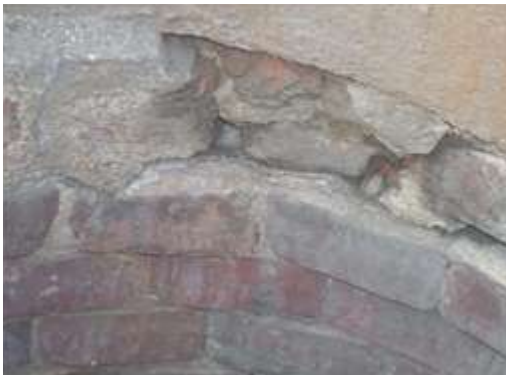
Defect 3

**Chimney / Frame Adjustment** ☒ Exists Material: **Stone** ☐ Parged Height: **3** (in.)

Condition: ☐ Sound ☐ Cracked ☐ Root Intrusion ☐ Loose Brick ☒ **Deteriorated**

DETERIORATION OF CHIMNEY

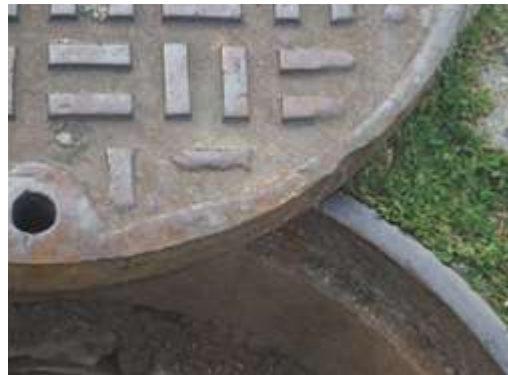
Defect 2

Condition: **Worn**

WORN COVER

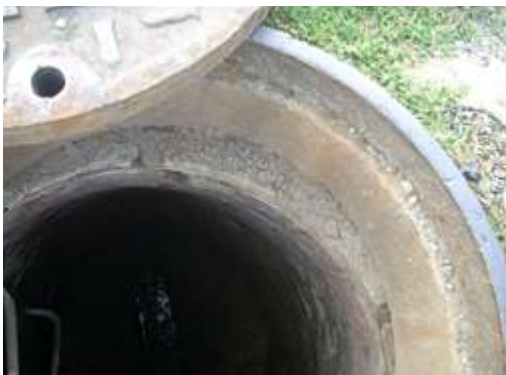
Defect 1

**Frame** Offset: **2** (in.) Condition: ☒ Sound ☐ Cracked ☐ Leaks

FRAME OFFSET

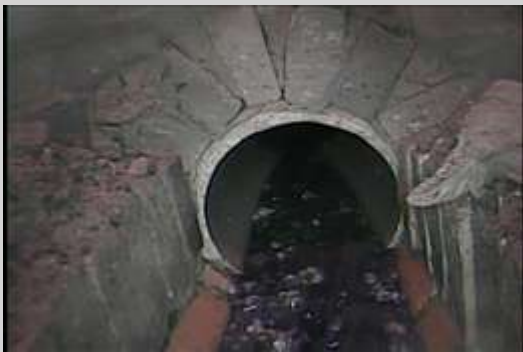
12 O'Clock Outflow

8 in. Circular Gravity Sewer  
Pipe Out @ 12 O'Clock

Pipe Height: **8.4** (in.) Rod and Bar (Angled)  
Pipe Material: **Clay** ☐ Pipe Lined  
Invert Depth: **9.12** (ft.) Flow Characteristics: **Slow**  
Deposits: ☐ None ☐ Mud ☐ Sludge ☒ **Debris** ☐ Grease  
Silt Depth: **2** (in.) Deposits Extent: **Light**  
Infiltration: **None** Pipe Seal Cond: **Sound**

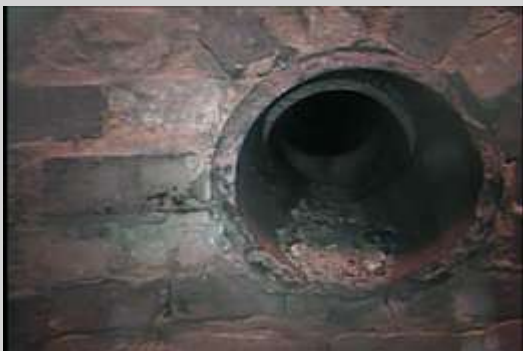
6 O'Clock Inflow

8 in. Circular Gravity Sewer  
Pipe In @ 6 O'Clock

Pipe Height: **8.4** (in.) Rod and Bar (Angled)  
Pipe Material: **Clay** ☐ Pipe Lined  
Invert Depth: **7.40** (ft.) Flow Characteristics: **Slow**  
Deposits: ☒ **None** ☐ Mud ☐ Sludge ☐ Debris ☐ Grease  
Silt Depth: (in.) Deposits Extent:  
Infiltration: **None** Pipe Seal Cond: **Sound**

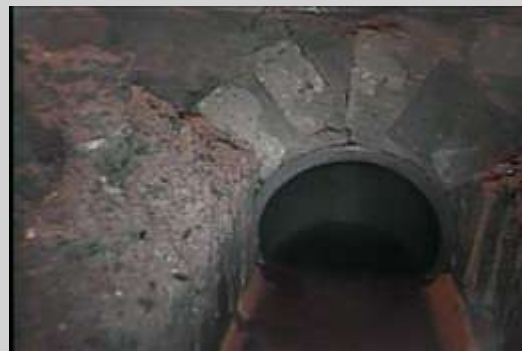
Drop In @ 6 O'Clock

Drop: **Outside** Rod and Bar  
Angled: **Yes** Reading: **8.20** (ft.)  
Inv Depth: **9.20** (ft.)

Drop Condition: **Open**
